# Freshwater fish values in Porirua Harbour catchment

# Porirua Harbour Fish survey locations NIWA database

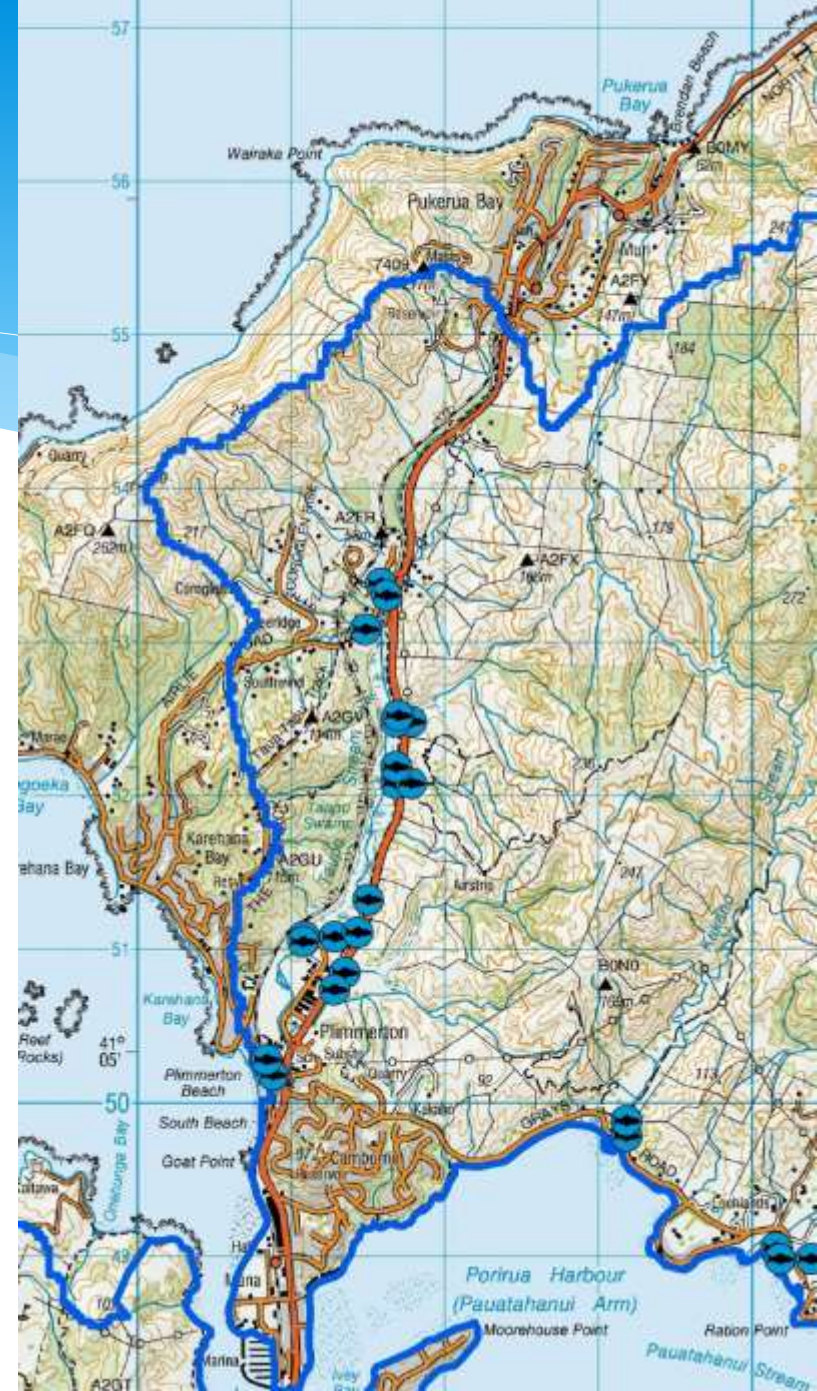
# Taupo Stream/swamp Kakaho Stream

Species	Threat Rank	# surveys	
		Taupo	Kakaho
Giant kokopu	At Risk-Declining	3	
Inanga	At Risk-Declining	2	2
Longfin eel	At Risk-Declining	7	2
Redfin bully	At Risk-Declining	2	2
Inanga	At Risk-Declining	1	
Shortfin eel	Not Threatened	4	2
Banded kokopu	Not Threatened	13	1
Common bully	Not Threatened		1
Giant bully	Not Threatened		1
Common smelt	Not Threatened		1
Grey mullet	Not Threatened	1	
Estuarine triplefin		2	
Koura	Not Threatened	2	
Freshwater shrimp	Not Threatened	1	1
Unidentified eel	N/A	1	
No species found	N/A	4

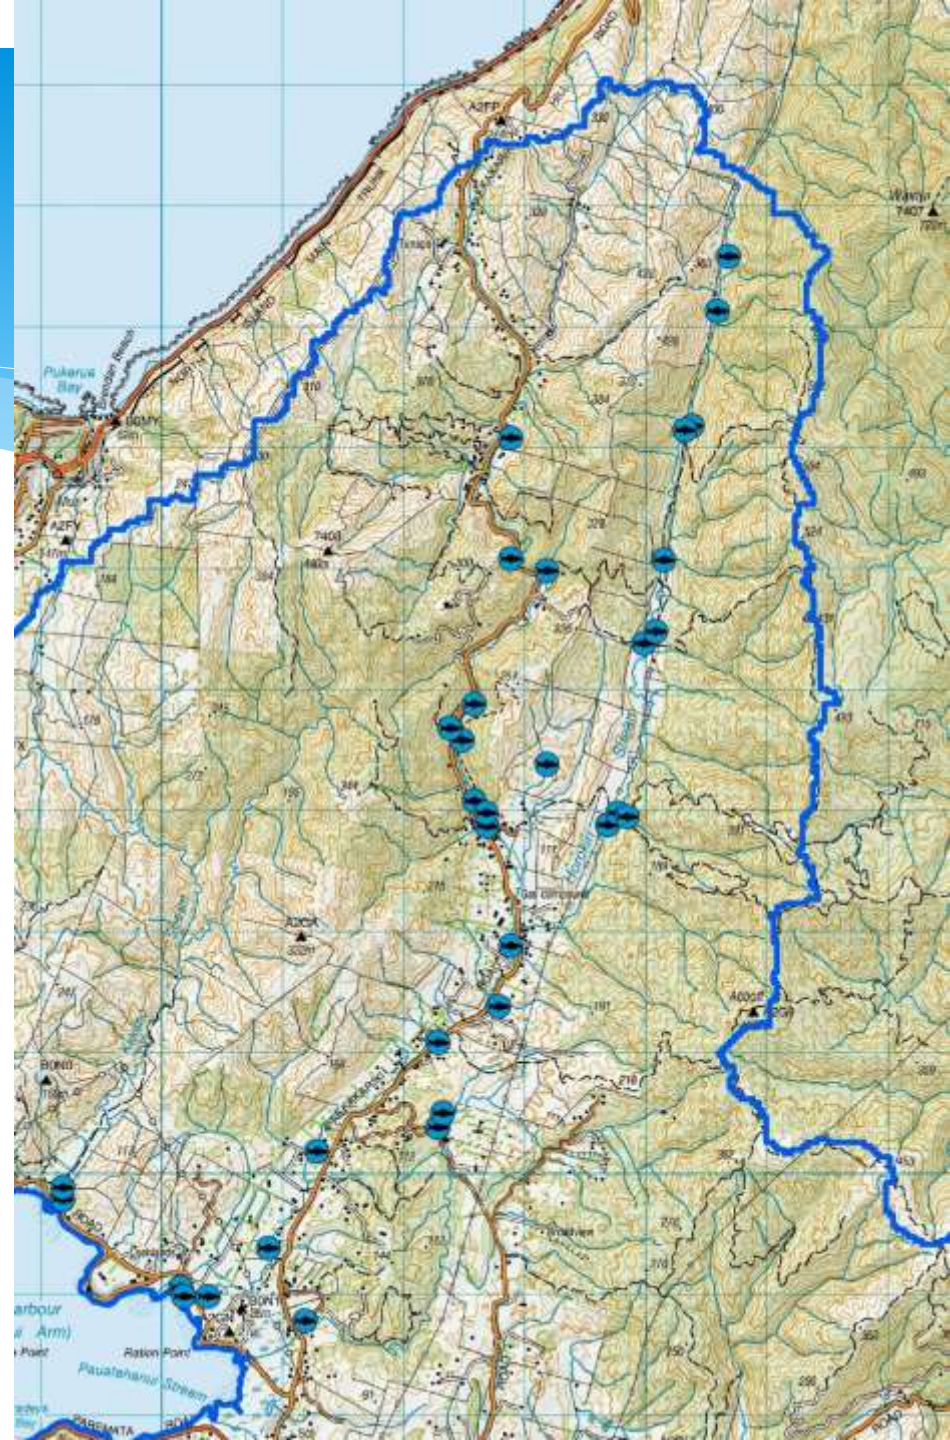
# Horokiri Stream Little Waitangi Stream (Ration Stream)

Species	Threat Rank	Horokiri	Little Waitangi (Ration)
Lamprey	Threatened-Nationally Vulnerable	7	1
Shortjaw kokopu	Threatened-Nationally Vulnerable	1	1
Giant kokopu	At Risk-Declining	8	2
Inanga	At Risk-Declining	7	1
Koaro	At Risk-Declining	4	
Longfin eel	At Risk-Declining	27	1
Redfin bully	At Risk-Declining	25	2
Torrentfish	At Risk-Declining	2	
Banded kokopu	Not Threatened	9	2
Common bully	Not Threatened	10	1
Giant bully	Not Threatened	1	
Koura	Not Threatened	7	
Shortfin eel	Not Threatened	24	1
Black flounder	Not Threatened	2	
Common smelt	Not Threatened	5	1
Yelloweye mullet	Not Threatened	3	
Estuarine triplefin	N/A	2	
Unidentified eel	N/A	5	
Unidentified flounder	N/N	1	
Brown trout	Introduced and naturalised	14

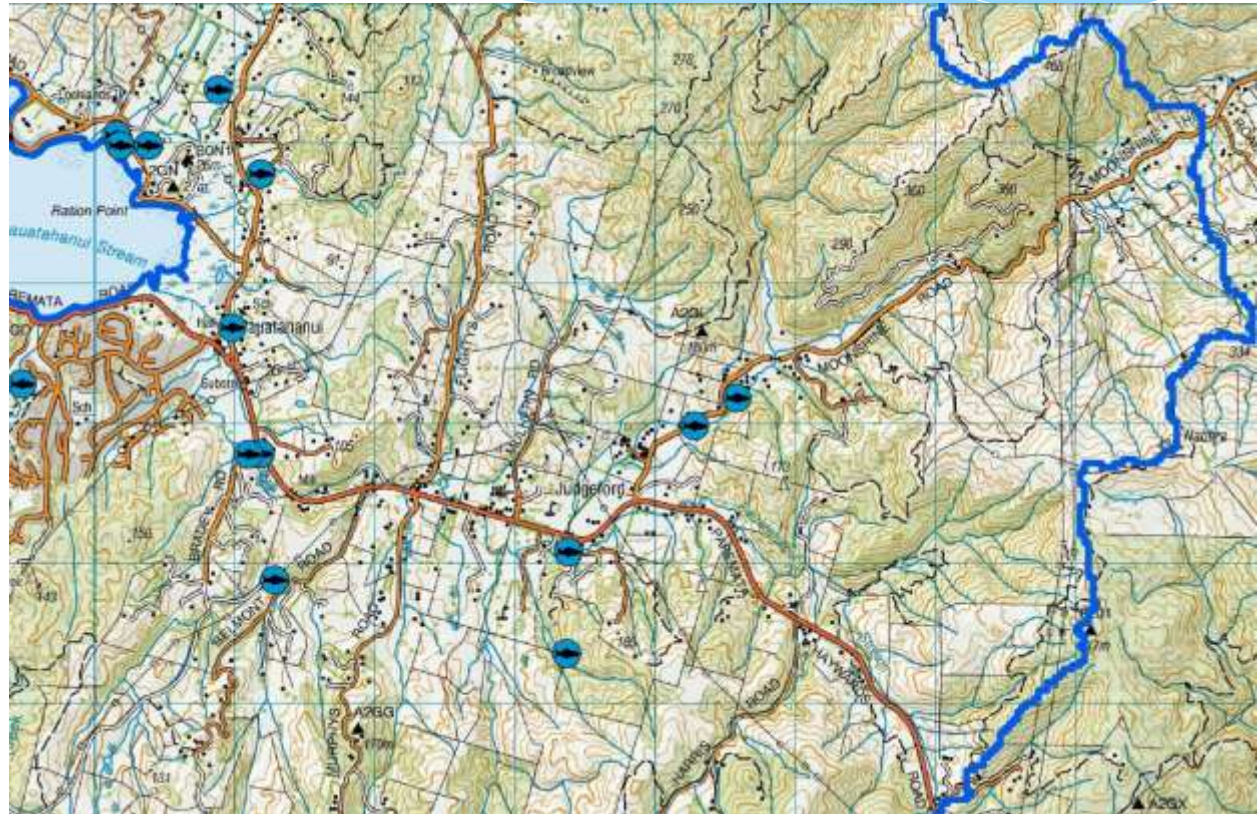
# Pauatahanui Stream

Species	Threat Rank	Pauatahanui
Lamprey	Threatened-Nationally Vulnerable	2
Longfin eel	At Risk-Declining	5
Freshwater mussel	At Risk-Declining	1
Giant kokopu	At Risk-Declining	2
Inanga	At Risk-Declining	5
Redfin bully	At Risk-Declining	4
Shortfin eel	Not Threatened	5
Banded kokopu	Not Threatened	2
Common bully	Not Threatened	3
Koura	Not Threatened	1
Freshwater shrimp	Not Threatened	1
Common smelt	Not Threatened	2
Brown trout	Introduced and naturalised	3
Unidentified eel	N/A	3
Unidentified Galaxiid	N/A	1

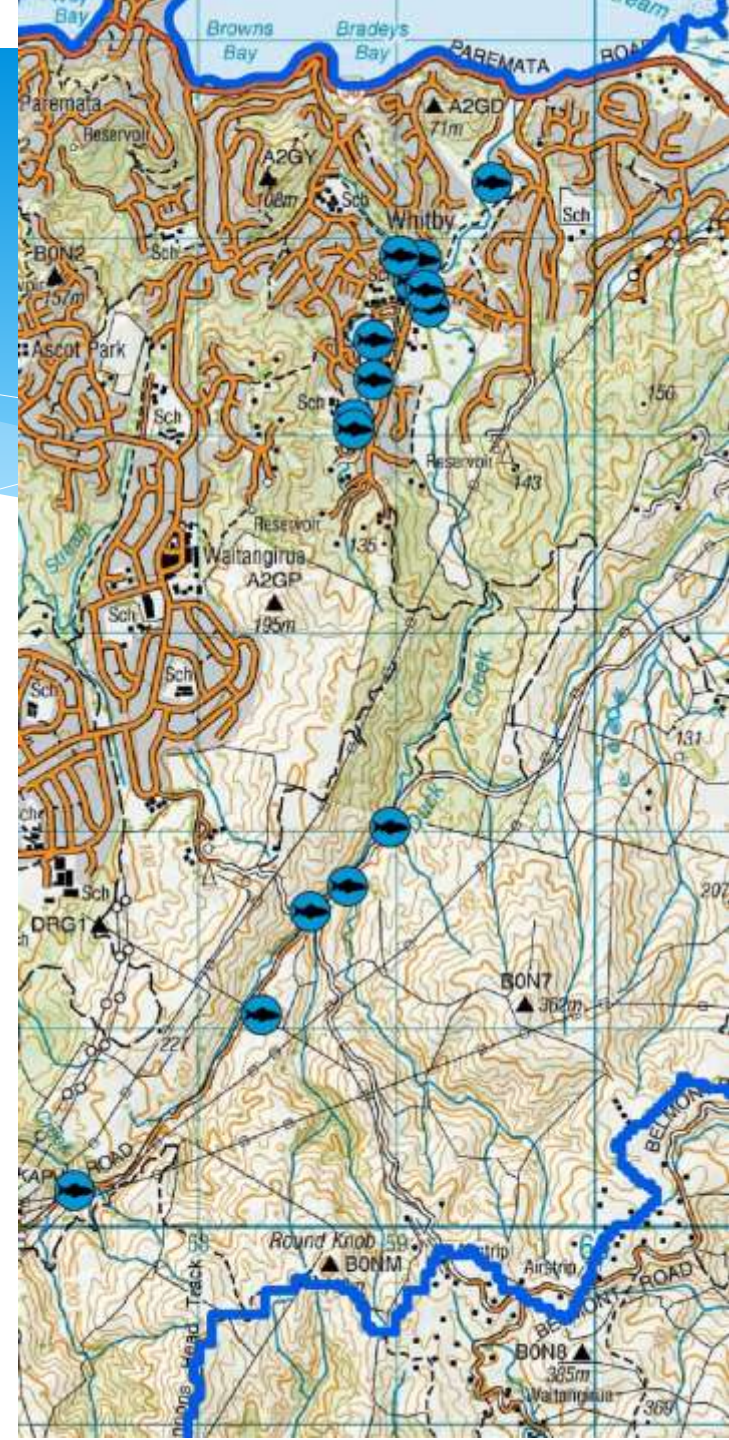
# Duck Creek

Species	Threat Rank	Duck Creek
Lamprey	Threatened-Nationally Vulnerable	1
Giant kokopu	At Risk-Declining	6
Inanga	At Risk-Declining	5
Koaro	At Risk-Declining	4
Longfin eel	At Risk-Declining	12
Redfin bully	At Risk-Declining	7
Banded kokopu	Not Threatened	5
Common bully	Not Threatened	4
Common smelt	Not Threatened	1
Freshwater shrimp	Not Threatened	5
Koura-ŋá	Not Threatened	4
Shortfin eel	Not Threatened	10
Bully sp.	N/A	1
No species found	N/A	1
Unidentified eel	N/A	1
Unidentified Galaxiid	N/A	5

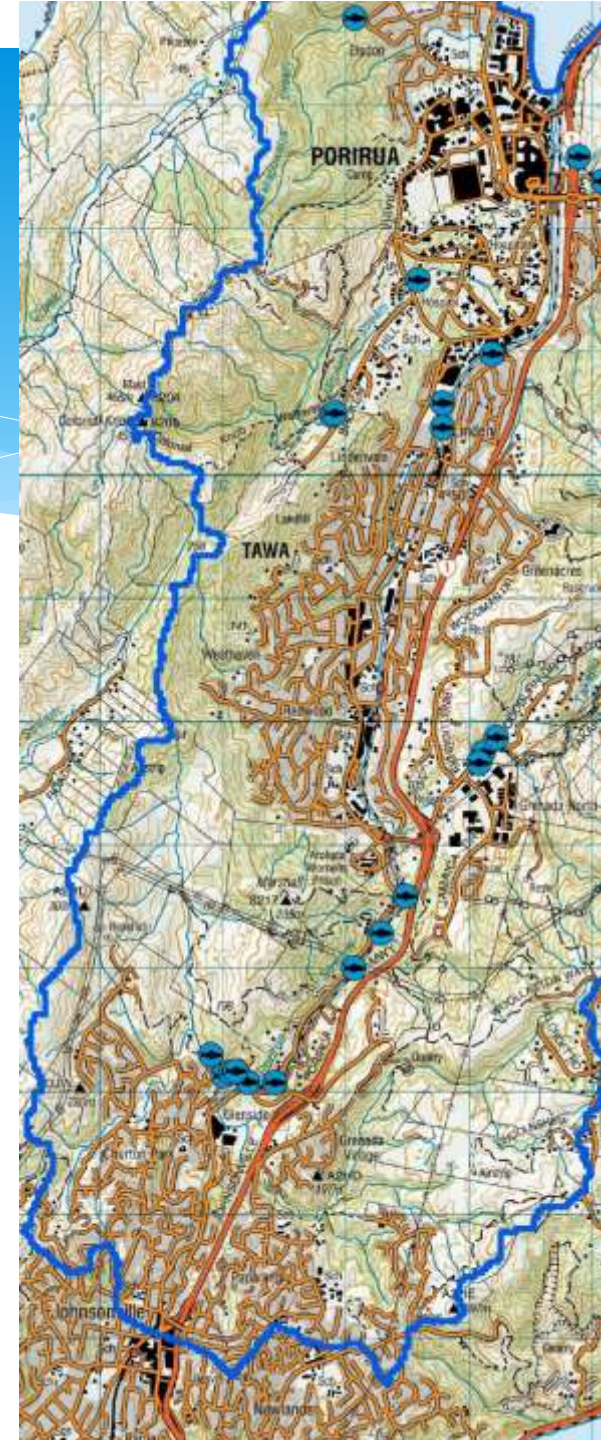
# Porirua Stream and Takapu Stream

Species	Threat Rank	Porirua	Takapu
Giant kokopu	At Risk-Declining	2	
Inanga	At Risk-Declining	2	
Koaro	At Risk-Declining	1	1
Longfin eel	At Risk-Declining	18	2
Redfin bully	At Risk-Declining	4	
Banded kokopu	Not Threatened	0	2
Common bully	Not Threatened	17	
Common smelt	Not Threatened	2	
Giant bully	Not Threatened	1	
Koura	Not Threatened	2	1
Shortfin eel	Not Threatened	8	1
Upland bully (East Coast South Island)	Not Threatened	2	1
Bully sp.	N/A	2	1
Unidentified eel	N/A	19	
Unidentified Galaxiid	N/A	3	
Brown trout	Introduced and naturalised	2

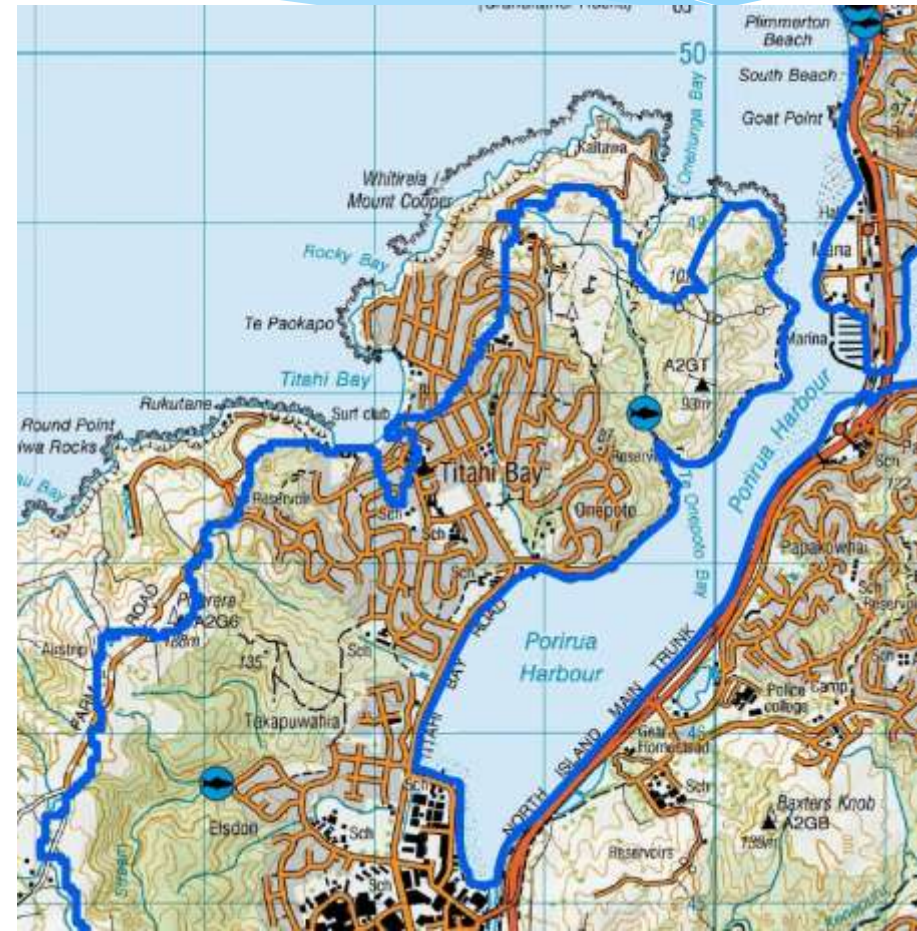
# Takupawahia Stream Te Onepoto Stream

Species	Threat Rank	Takupawahia	Te Oneopoto Bay
Inanga	At Risk-Declining		1
Longfin eel	At Risk-Declining	1	1
Redfin bully	At Risk-Declining	1	
Banded kokopu	Not Threatened	1	1
Shortfin eel	Not Threatened		1

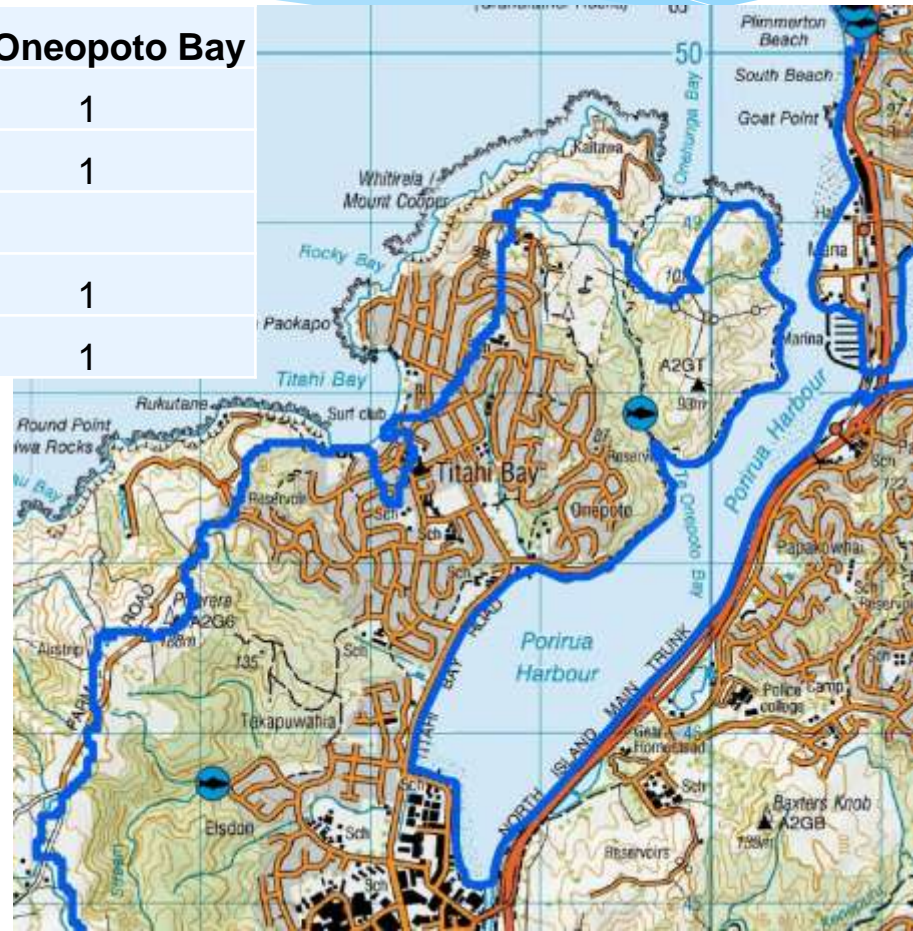
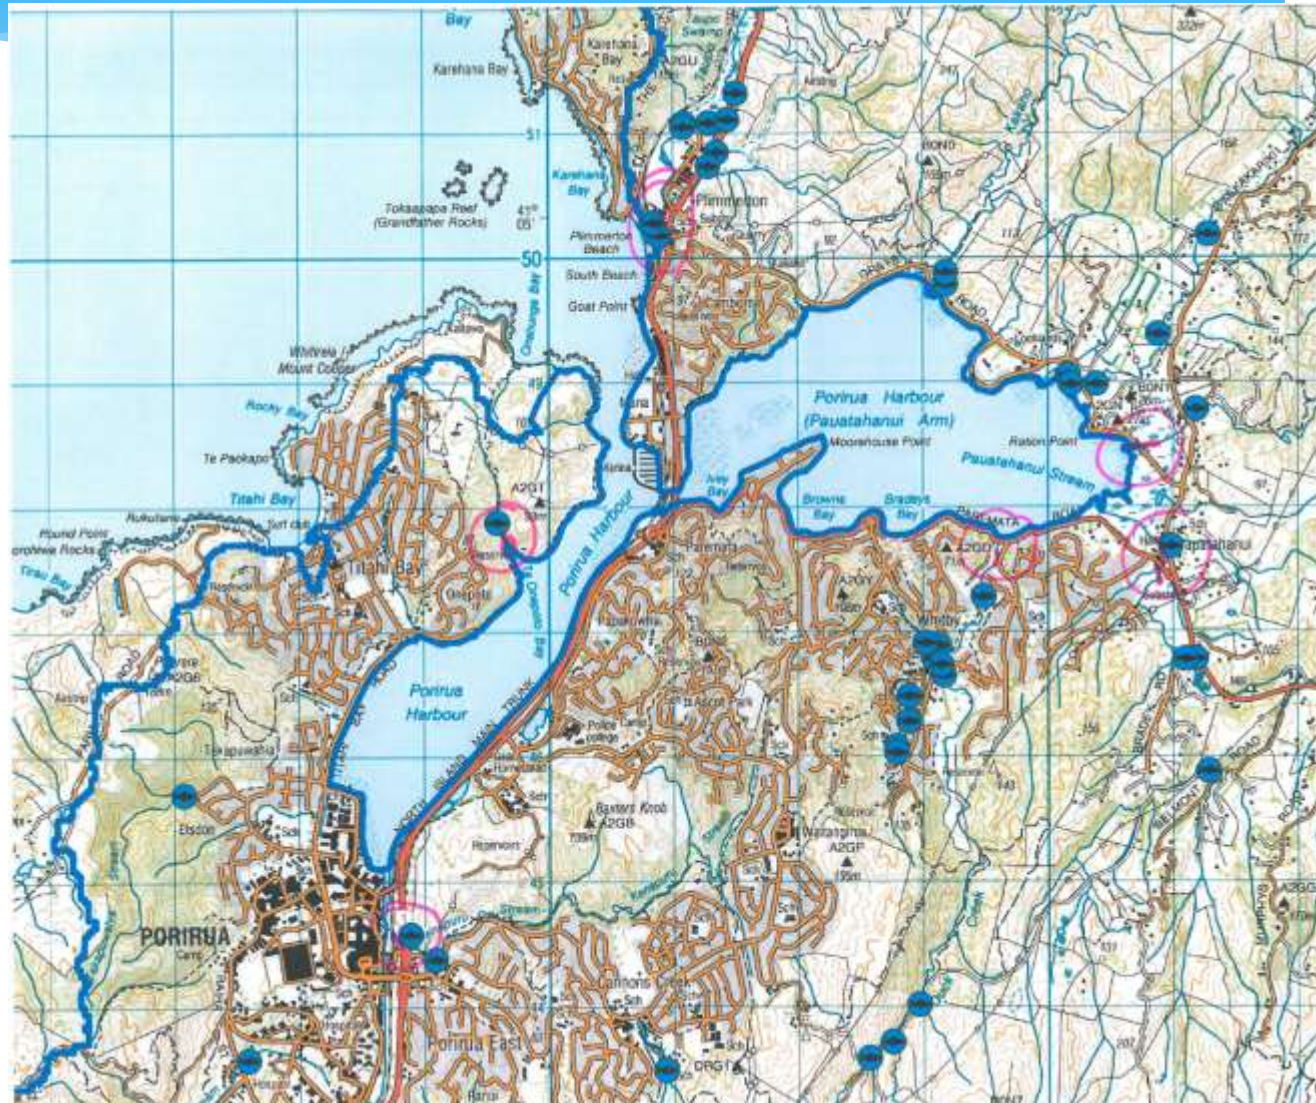
# Inanga spawning

Inanga shoals seen

Inanga rearing habitat

Inanga egg laying habitat (circled, red next map)

(Blue next map = reach surveyed)

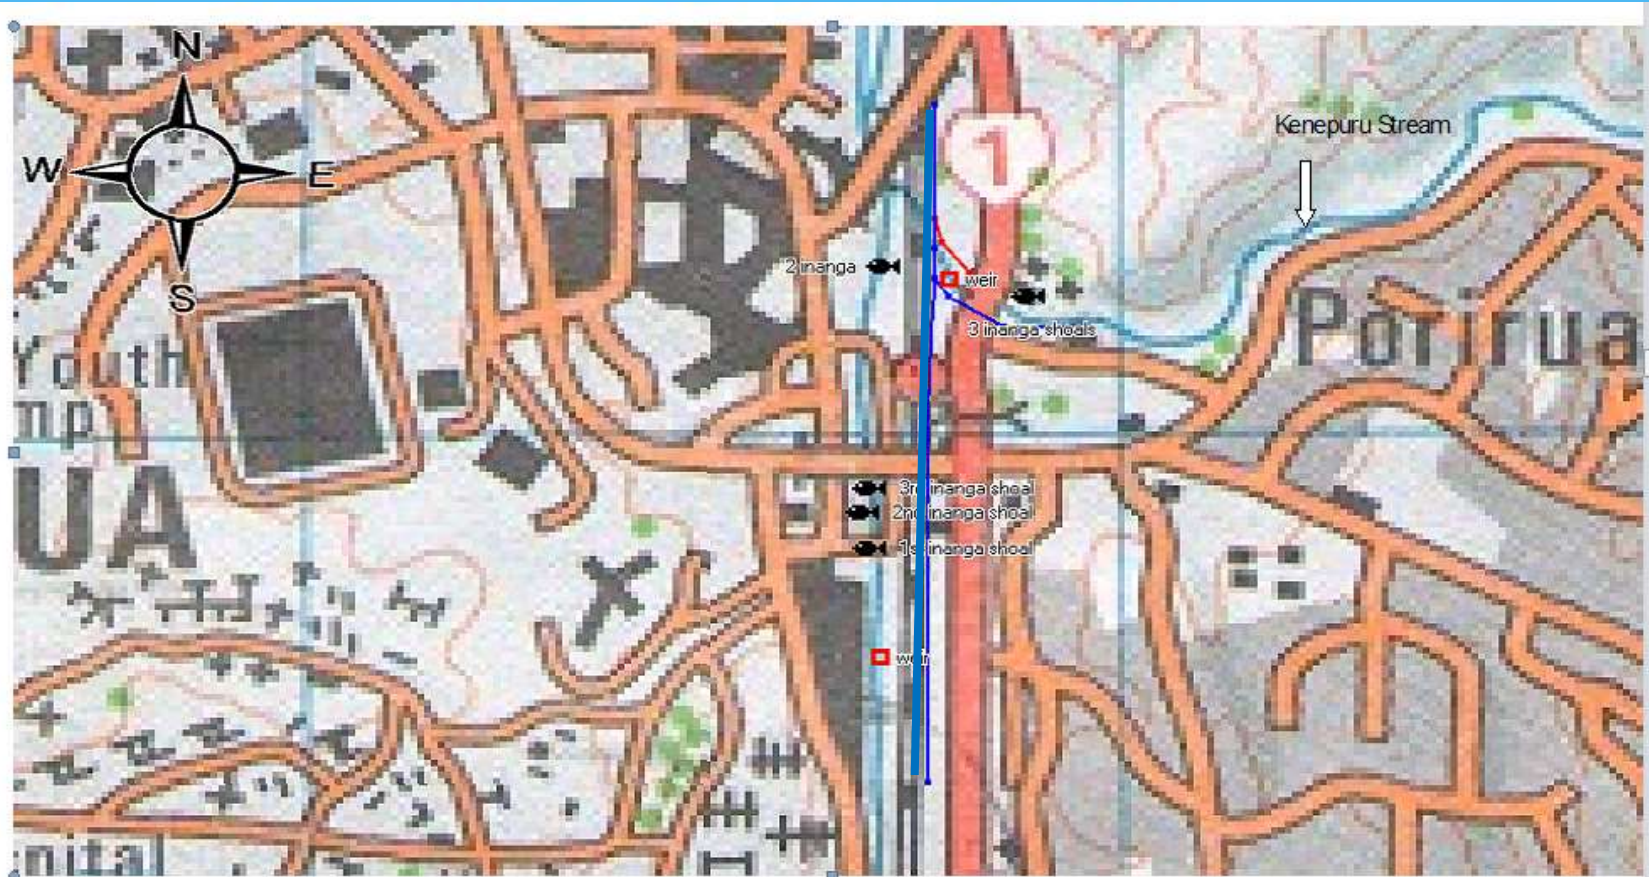
Figure 22: Survey extent (blue), and area of potential spawning grounds (red) on the lower reaches of Porirua Stream.

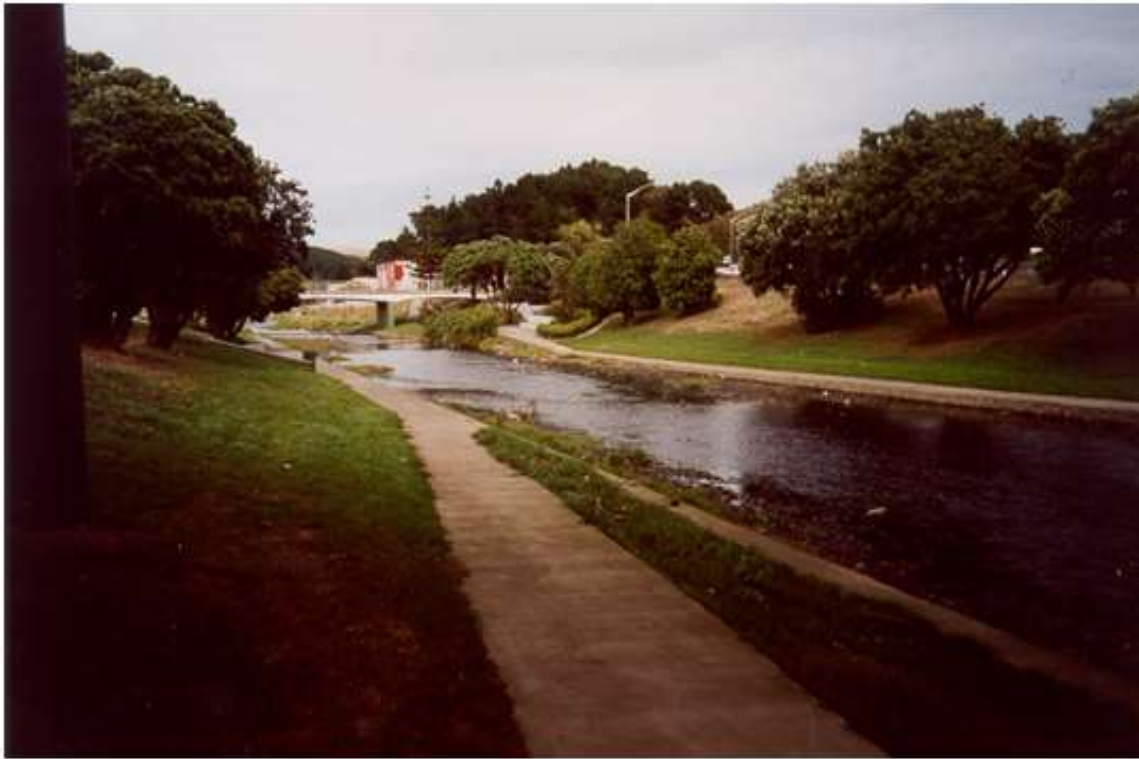
**Figure 24:** Three large shoals of inanga were observed in the shallow reach of Porirua Stream between the two bridges. Note the vertical concrete-clad banks on each side of the stream.

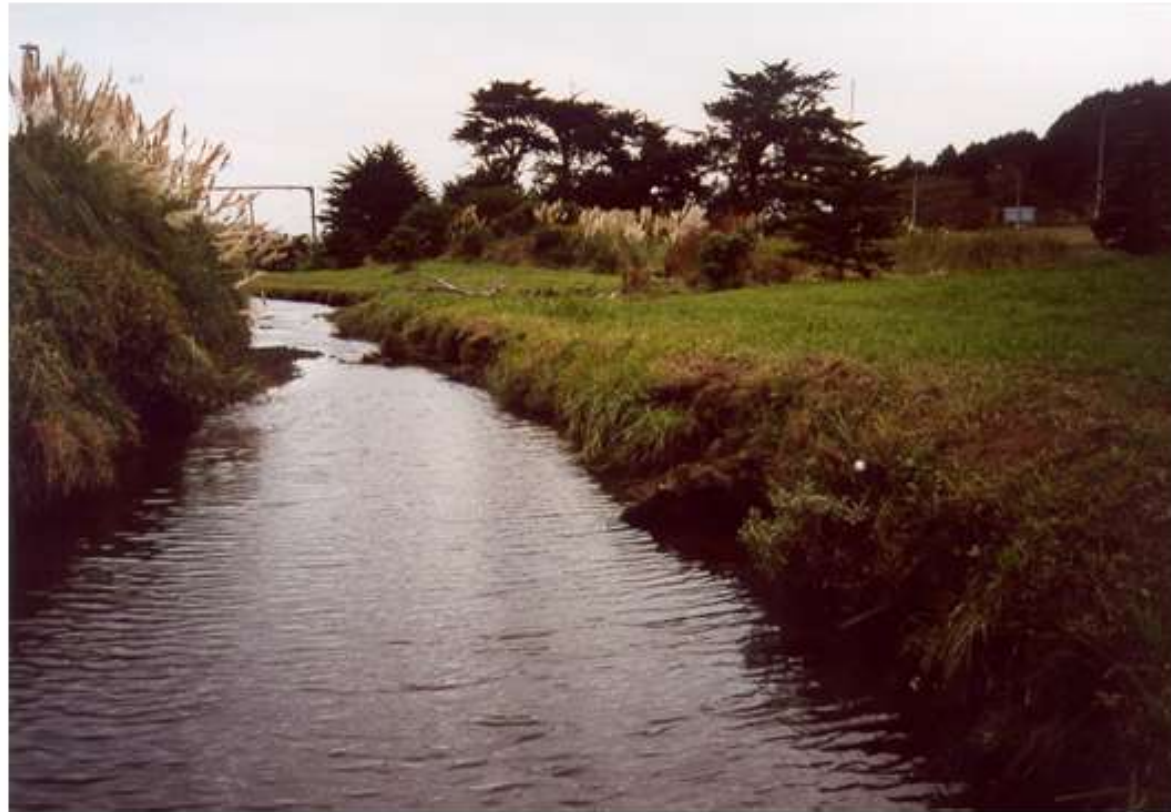
**Figure 25:** Kenepuru Stream, looking downstream below the weir. The right bank (S.H. 1 side) has the best potential for spawning habitat restoration. It already comprises established toe toe and raupo vegetation.

Not toe toe but pampas – however still fulfils role of foliage in water for spawning

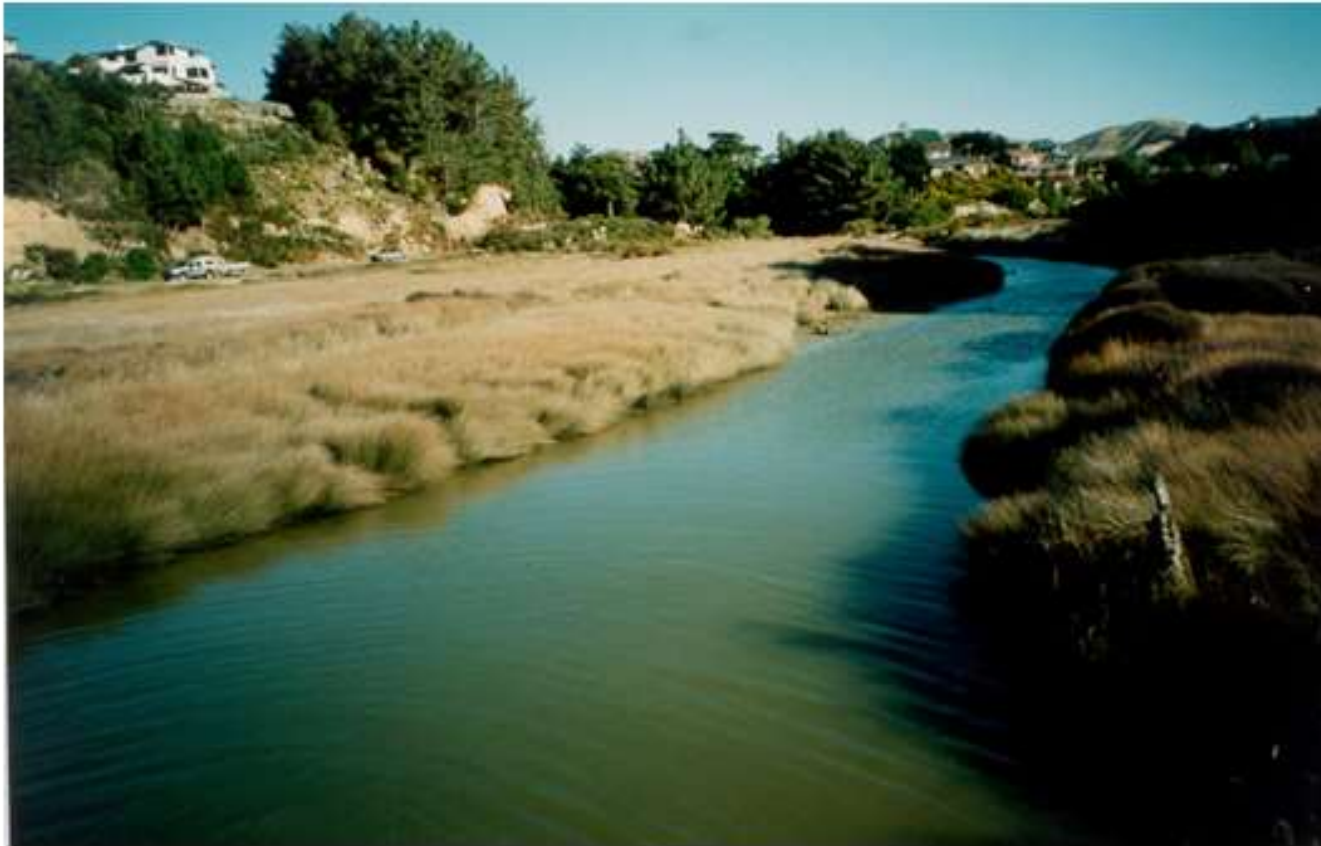
**Figure 28:** Extensive saltmarsh at the mouth of Duck Creek.

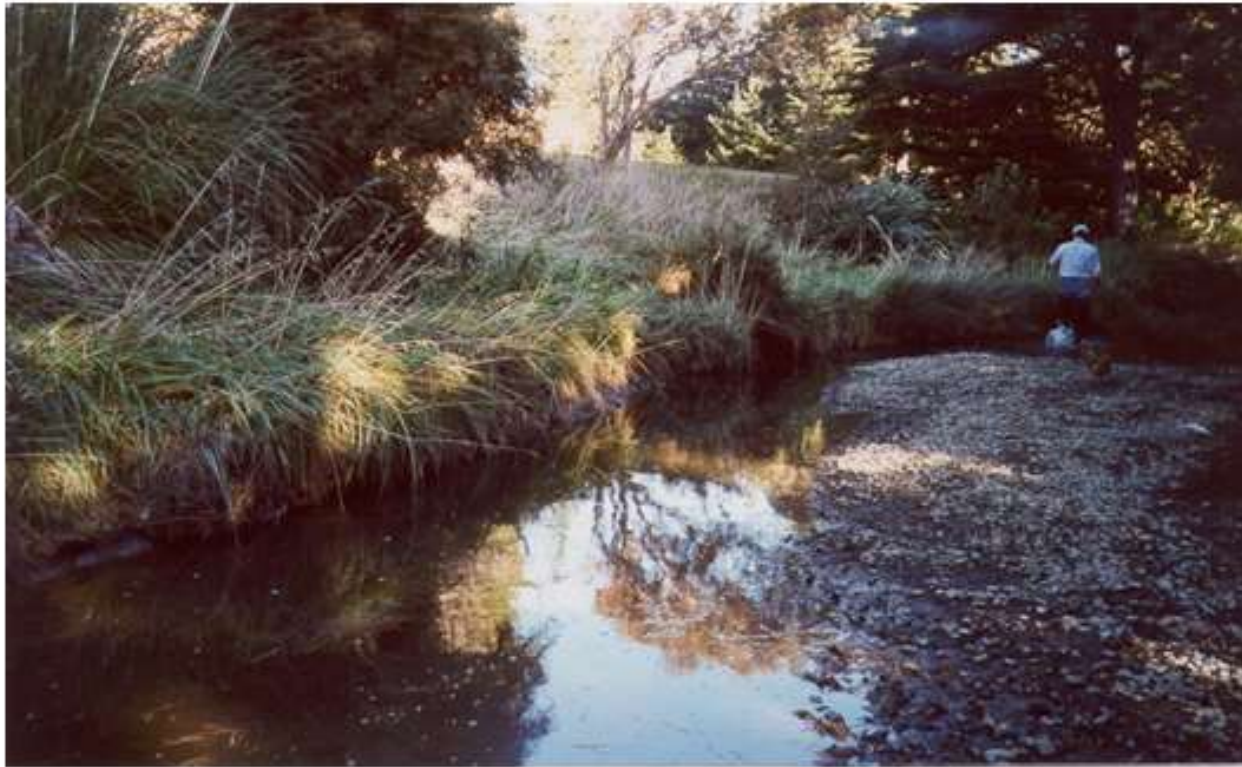
**Figure 29:** Suitable spawning vegetation downstream of the Whitby golf course on Duck Creek. The plant community comprised a mixture of tall fescue, toetoe and flax.

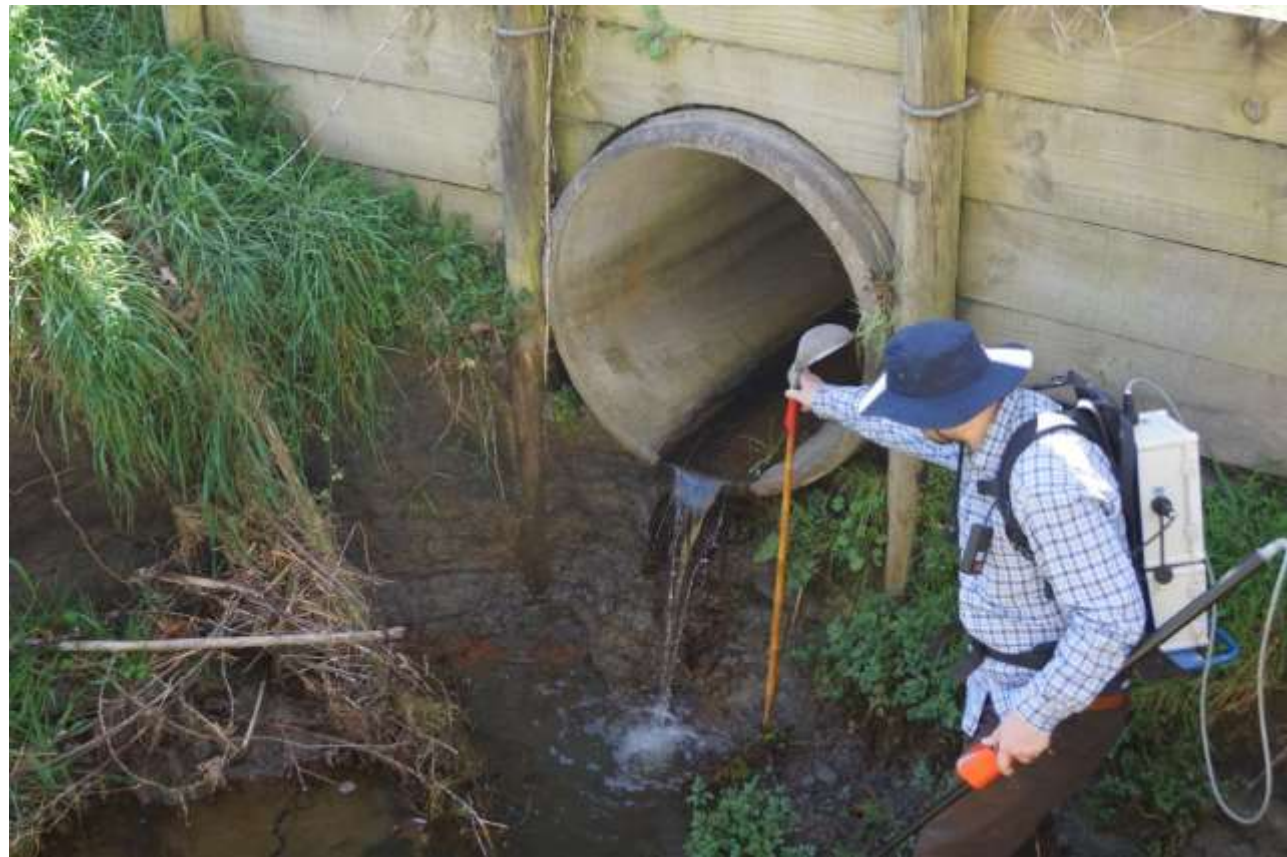
Structures can create barriers  
Speed up flow  
Big drop  
A few species climb  
Not overhangs

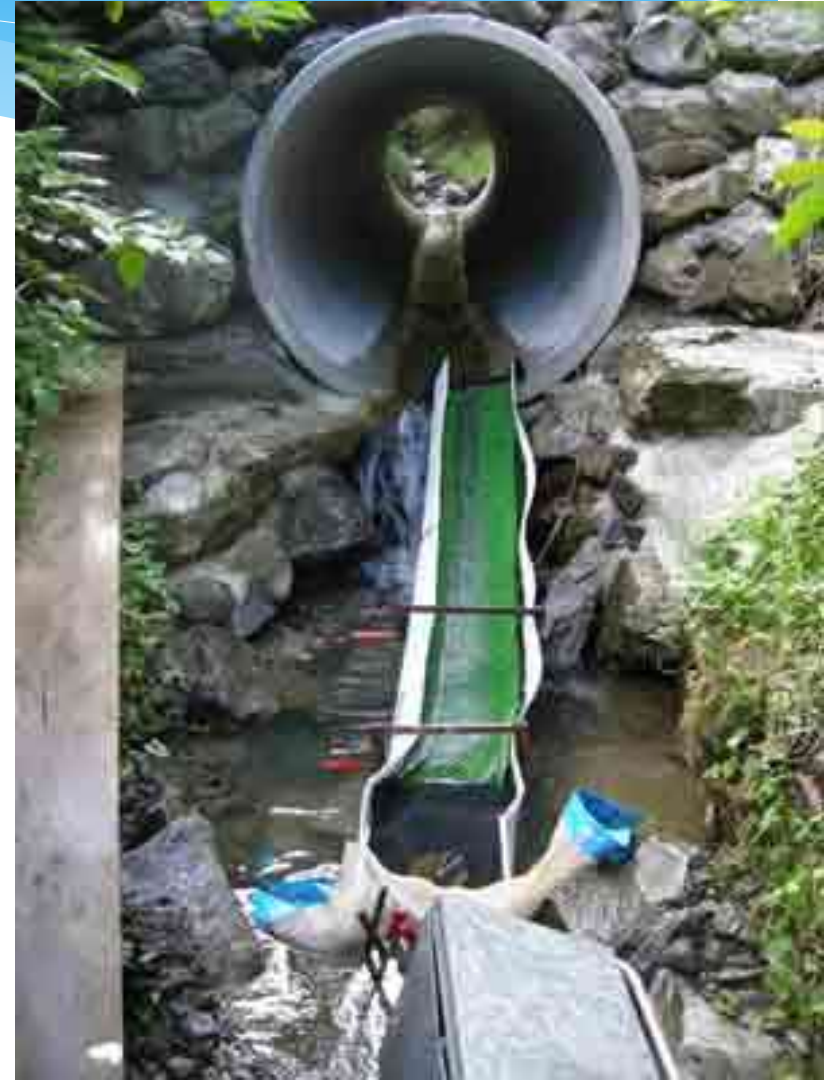
Laboratory experiments showed that the climbing ability of poor-swimming fish species, such as inanga (*Galaxias maculatus*), depended on fish size and the length and slope of the ramp to climb, but not the availability of resting pools.

Further, *in situ* experiments conducted at 13 culverts showed that fish could not pass (0% passage) undercut (perched) culverts unless aided by an experimental ramp (43% passage)

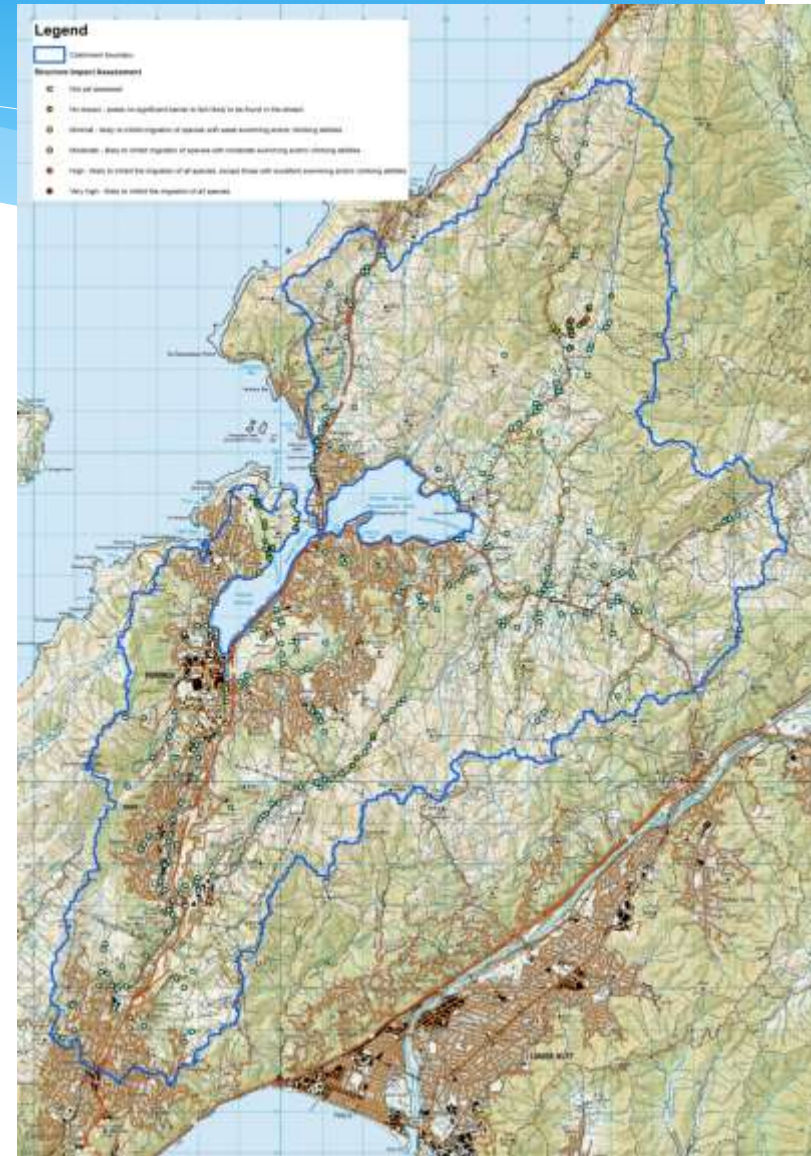
# Structures in waterways

Greater Wellington Regional Council survey, but effects of many structures not yet assessed, and not all structures catalogued

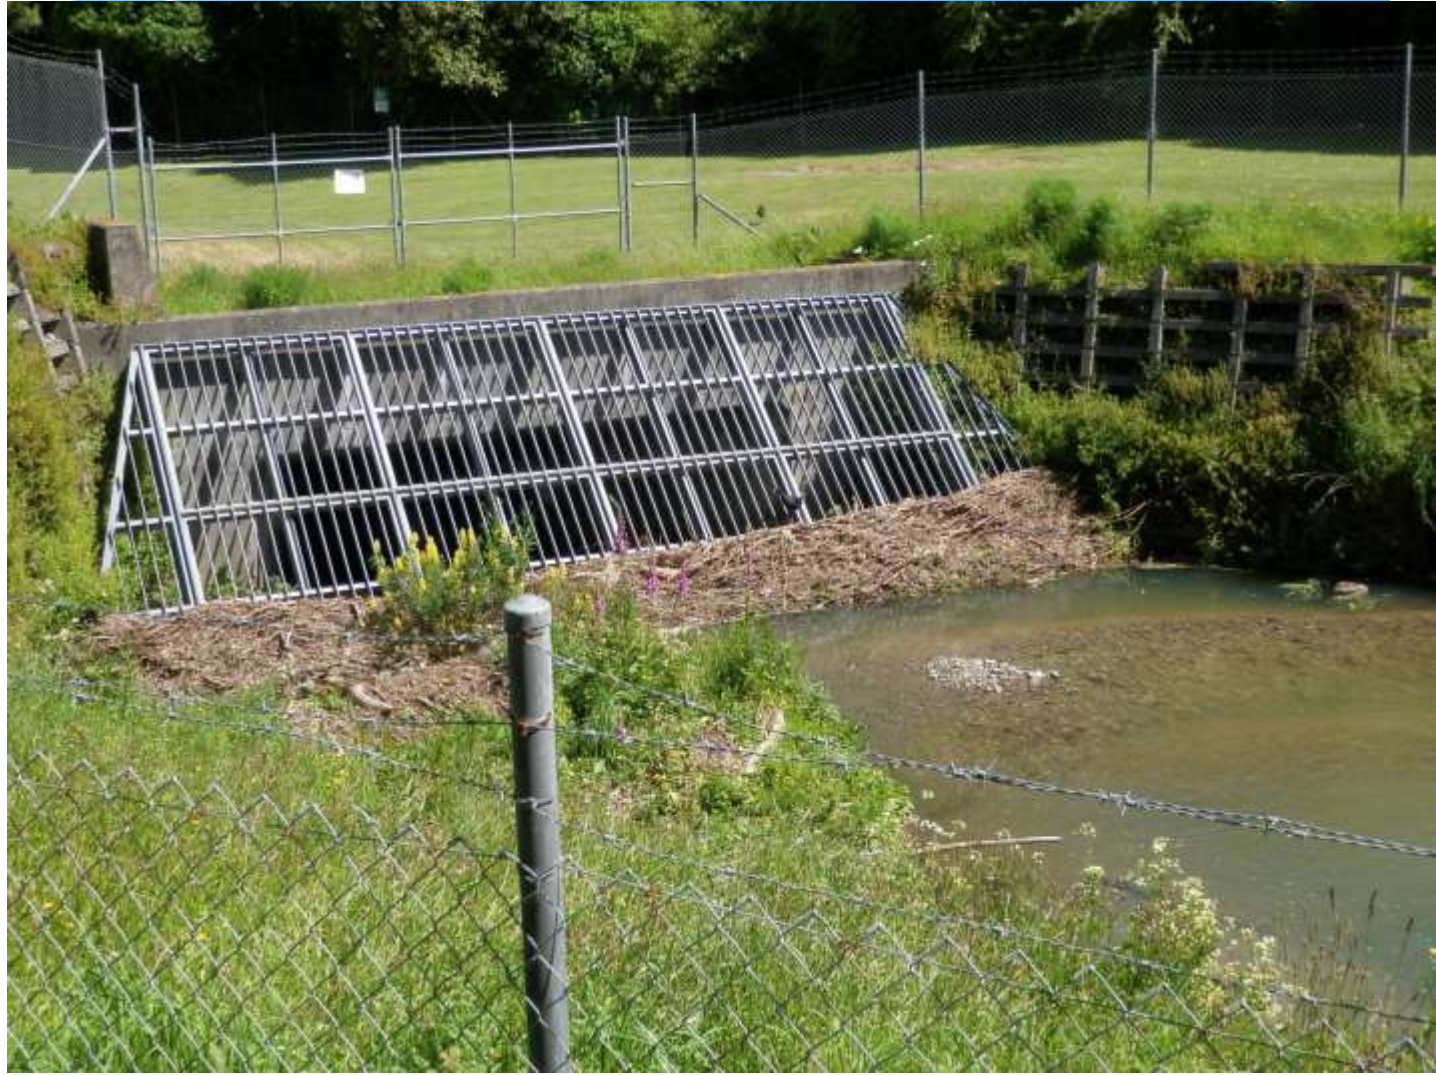
Debris in stream is habitat for aquatic species  
But  
Can be flood hazard
